RAIL OVER ROAD BRIDGE STRIKES – DISCUSSION OF AN EMERGENCY RECOVERY IN A METRO AREA

Jennifer Critchley¹, Emma Cowell²

Bridge 30 Wairarapa Line (Br 30 WL) is near Silverstream in Upper Hutt, New Zealand. Br 30 WL was struck by a vehicle and badly damaged in January 2015. This section is not intended to be a discussion of the technical details of the repairs used at this site as the calculations and detailing used were relatively straightforward and are not of particular note in themselves. The intention of this section is to illustrate a typical timeline of an emergency recovery project and to discuss the management structure and decision making processes used to achieve a fast and safe return to service.

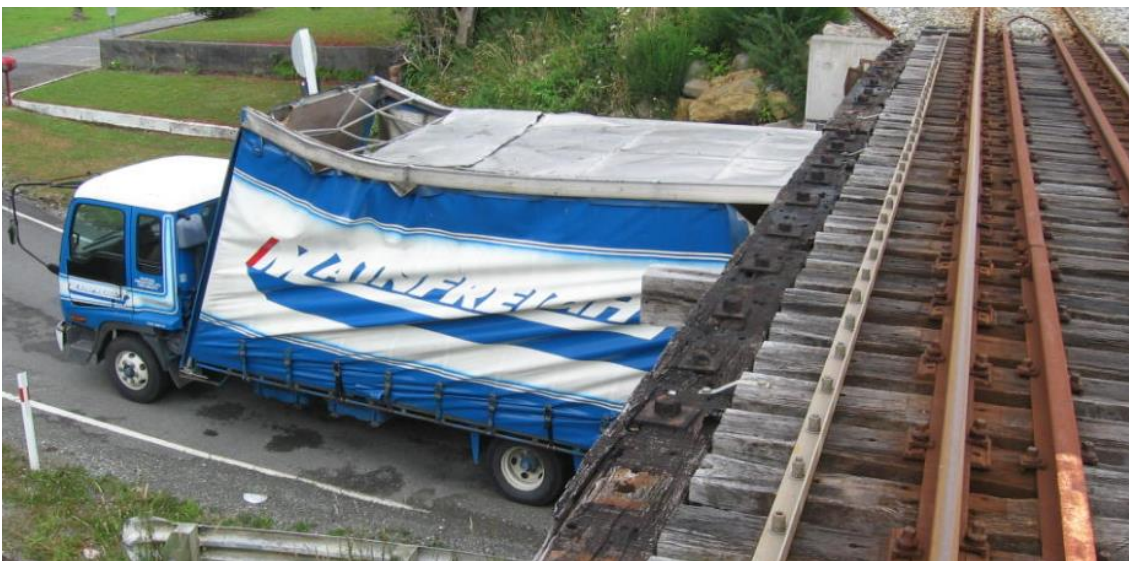
Picture 1 - A typical example of a truck that has come off worse after a bridge impact with little actual damage to the bridge span (Photo Credit: Unknown)

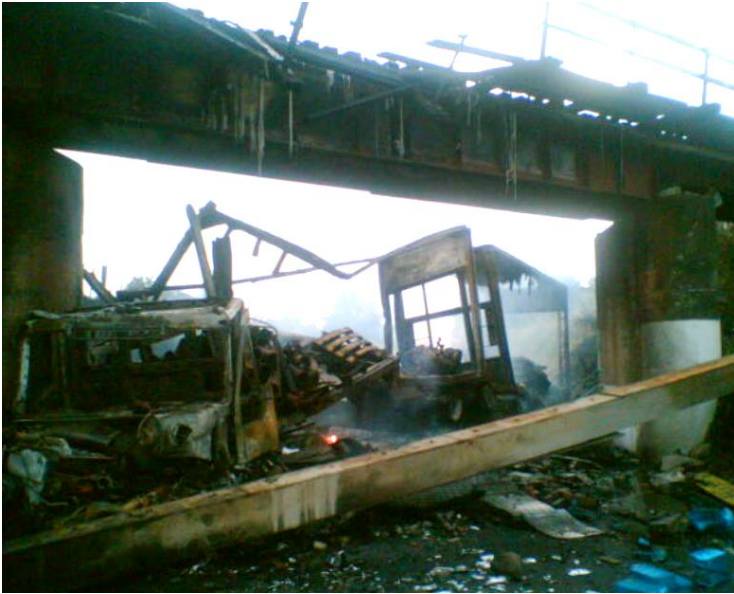
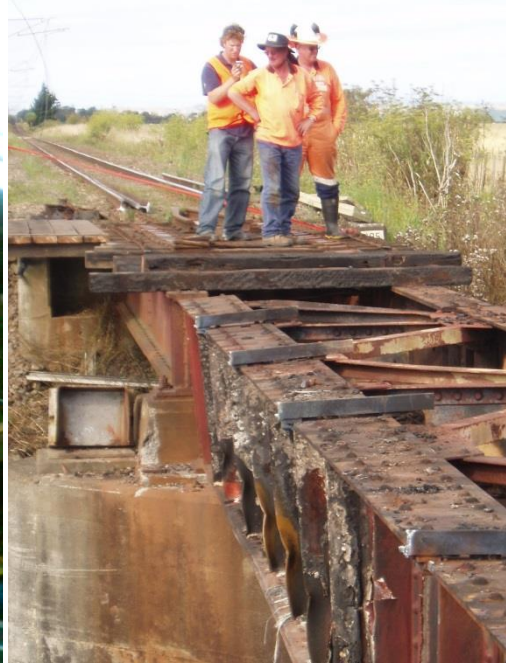
Picture 2 and 3 – A particularly bad example of damage to a span. The truck caught fire after it became wedged under a span of a rail bridge over SH1 near Marton. No-one was injured at this incident. (Photo Credit: Richard Greenfield)

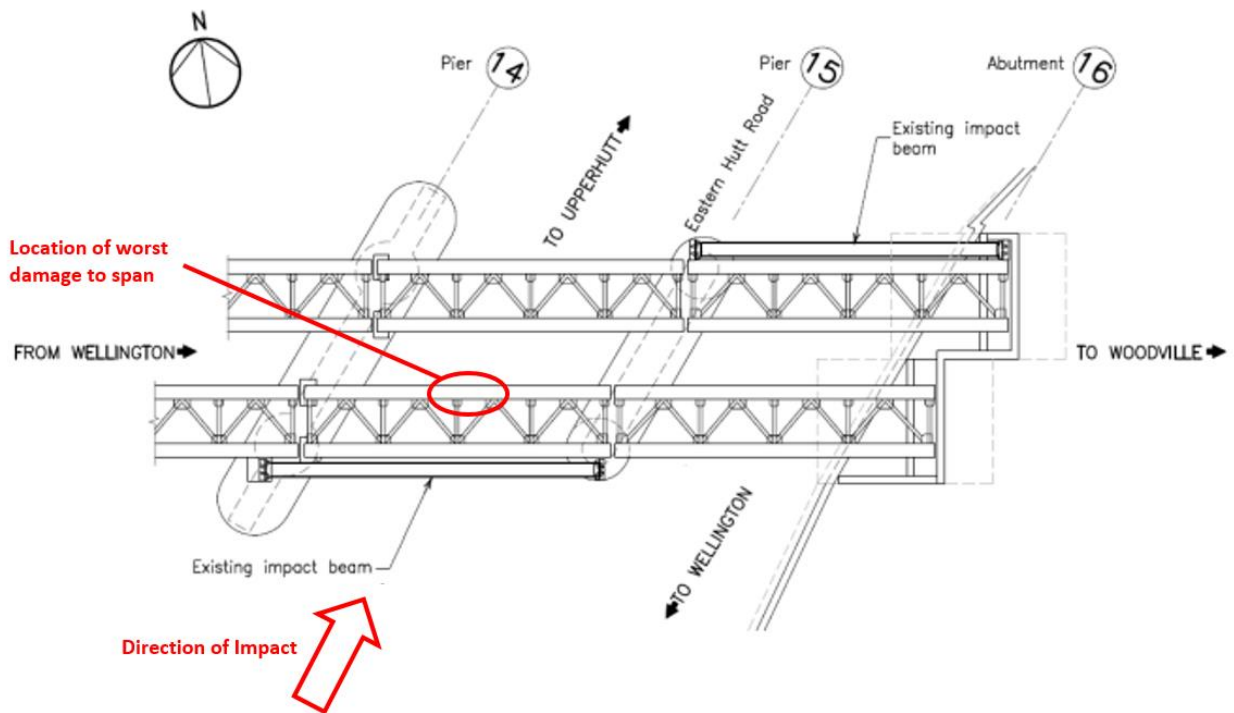
Figure 4 – Plan view of the Br 30 WL spans over the road and the location of worst damage

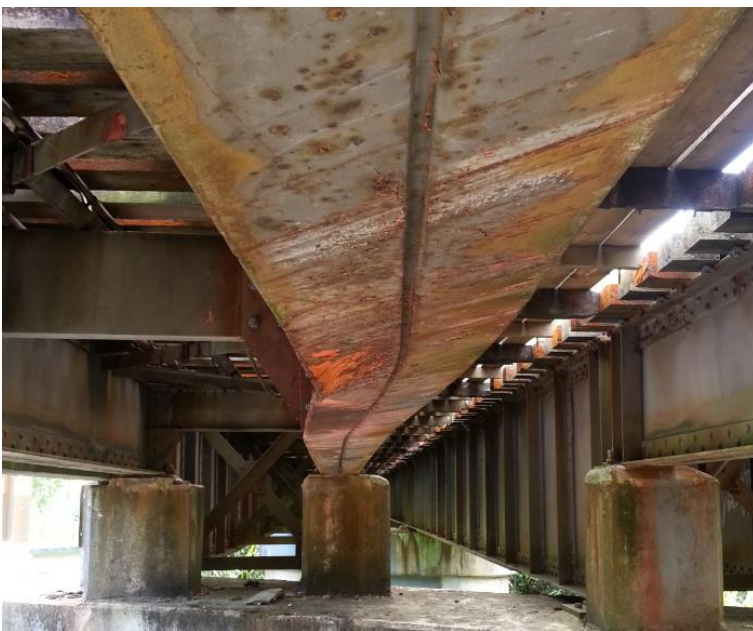
From an inspection of the damage to the impact beam and the span and piers it appears that the impact beam was the first part of the structure to be hit. The force of the impact appears to have cartwheeled the forklift up into the first span, causing the damage to the bottom flange of the span, before falling off the flatbed sideways and gouging the concrete of the pier.

- Side 1 SPG – Bottom Flange
 - 150mm global deformation laterally of bottom flange
 - 90mm local deformation laterally of bottom flange (over a 1600mm distance)
 - 45mm local deformation vertically of bottom flange
 - Localised flange tearing at the point of maximum deflection
 - Buckling in the web
 - Yielding of bolts to the centre diaphragm
 - Some cracking in concrete around holding down bolts
- Side 2 SPG - Top Flange
 - Yielding of bolts to the centre diaphragm
 - Some cracking in concrete around holding down bolts
- Side 1 and 2 - Top Flange
 - No obvious deformation or damage but approx. 10mm lift in track level at the point of impact.
- Impact Beam
 - Deformation of approx. 40mm laterally
 - Holding down bolts at both ends yielded

Picture 5 - Side 1 bottom flange global lateral deflection (Photo Credit: Michael Luke)

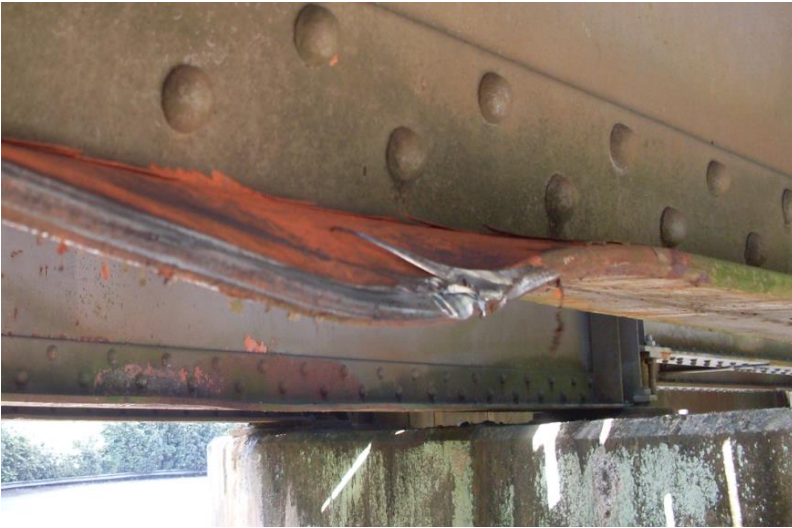
Picture 6 – Approx 60mm tear in bottom flange (Photo Credit: Graham Boorman)

The technical design of the temporary bracing solution was relatively simple. While the span was clearly badly deformed and unsuitable for use, analysis of the remaining effective sections suggested that there was sufficient capacity remaining in the damaged girder after an allowance had been made for the section area lost to the tear in one of the flange angles.

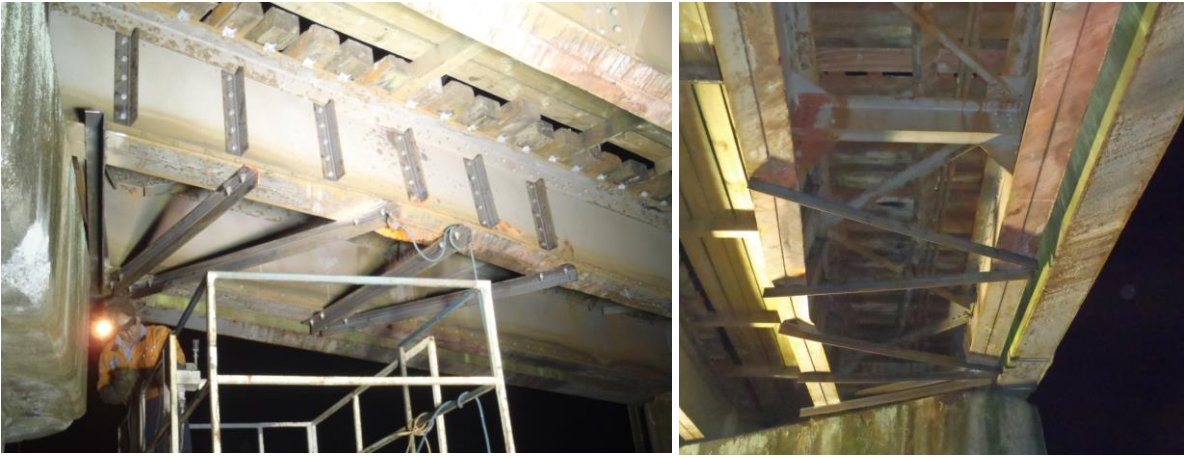
Picture 7 and 8 – Temporary cross bracing and web stiffeners installed (Photo Credit: Cody Young)

After discussion it was decided that both options were potentially valid and the difference in applied loading was nominal so the cross bracing was designed for lateral forces from both potential sources. The cross bracing was designed to intersect and transfer load to the existing undamaged span cross bracing and diaphragms.

The buckling in the web was dealt with by installing a 100x100 Equal Angle to brace the web and increase its flexural capacity at various points along the span. The flexural forces in the web and hence stiffener were estimated from the free body diagram in figure 3.

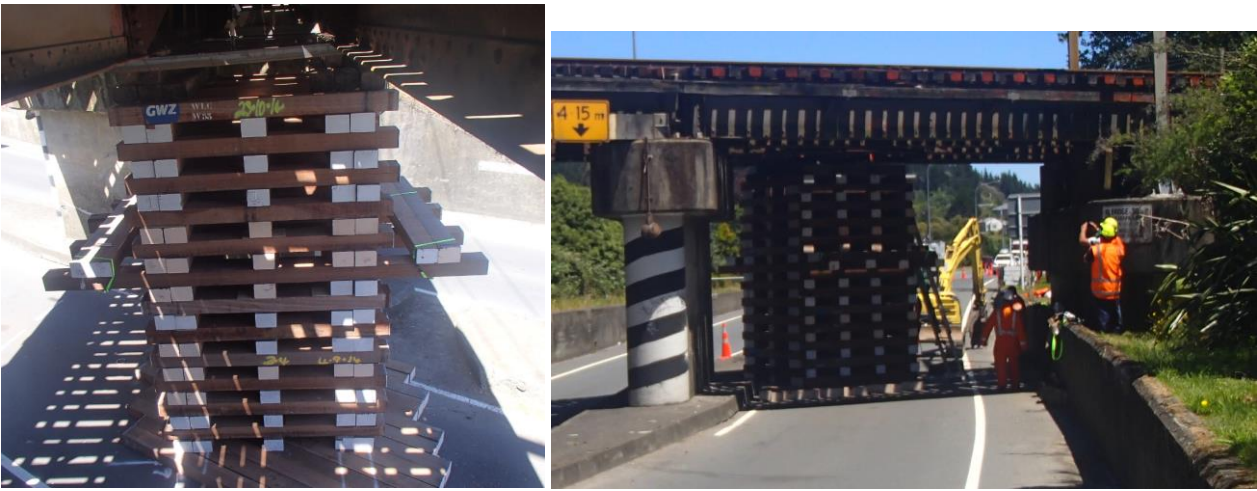
Picture 9 and 10 – The sleeper pigsty installed under the span (Photo Credit: Derek Jansen)
