Clipper Adventurer Grounding: Background and Geomatics Issues Bruce Calderbank, FRICS, CLS, CH, P. Eng. Chartered Hydrographic Surveyor, Certified Hydrographer Level 1 Hydrographic Survey Consultants Intl. Ltd., Calgary, Alberta, Canada

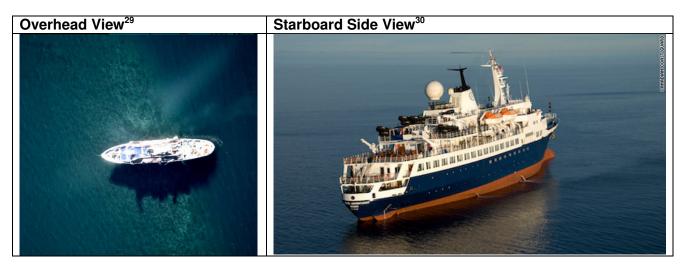
Figure 3 Clipper Adventurer Grounding

The grounding led to 13 of the vessel's double-bottom tanks being breached, some holding fuel, freshwater and sludge.²⁶ The damage was below the waterline and, consequently, the fuel oil was forced to the top of the tank due to the ingress of sea water. As a result, there was no leakage of the oil. The Canadian Coast Guard (CCG) also verified that at the time of grounding there was no sign of oil pollution in the vicinity of the grounded ship. However, several days following the grounding, a light sheen was visible but it dissipated quickly.²⁷

An overhead view of the grounded **Clipper Adventurer**, which clearly shows the rock shoal approximately 60 metres either side of the vessel is provided in the left Figure below. A starboard side view of the vessel with a list of 5 degrees to port shown in the right Figure below.²⁸

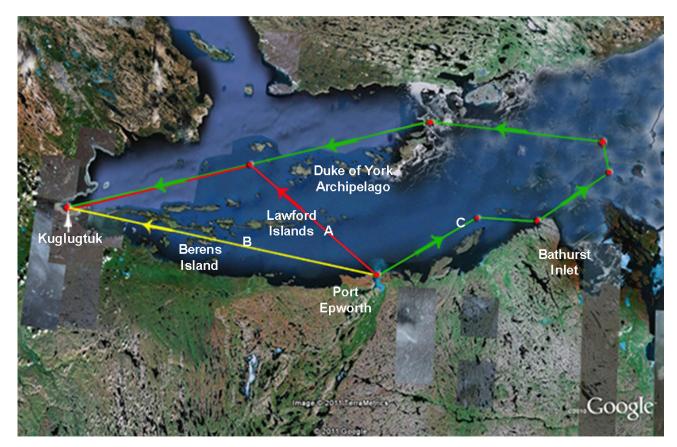
Figure 8 A) Route Chosen by Clipper Adventurer; B) Second Route Option; C) Reciprocal Route taken on 26 August⁵⁸

"The vessel was scheduled to arrive in Kugluktuk at 0800 on 28 August 2010. This arrival time could have been achieved by either the chosen route (A), 90 nautical miles to Kugluktuk at a speed of 6 knots, or by the longer route (C), 200 nautical miles at a speed of 13 knots. Either route would have allowed the vessel to reach Kugluktuk on schedule."⁵⁹

For unexplained reason(s), the captain made the **Clipper Adventurer** speed to be 13.9 knots over the shorter route,⁶⁰ which was not required to meet the vessel's schedule. Perhaps the fuel savings offered by sailing at the vessel's economical cruising speed over Route A was the driving factor in the choice of the route taken.

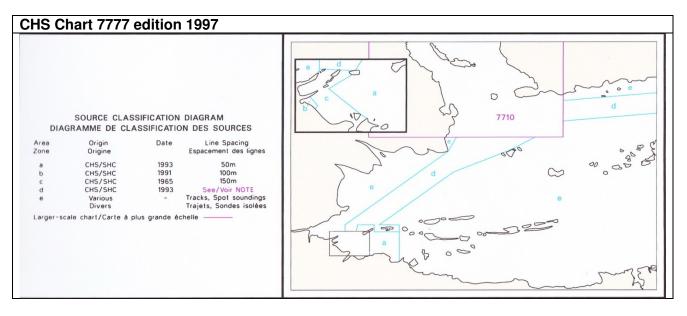
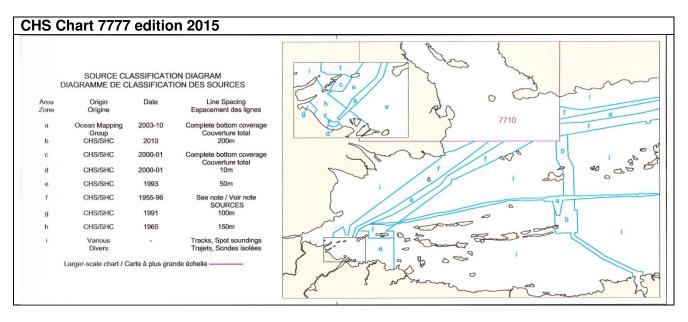
The source classification diagrams for CHS Chart 7777 for the 1997 and 2015 editions show the improvements in the bathymetry, and indicate the level of confidence in the soundings printed on the chart. The 1997 edition source classification diagram indicated that the area from below the magenta line which ran from the south west to the north east through the middle of the chart only contained track and spot soundings from various sources with no indication of when the soundings were made and depicted by Area "e".⁶⁴

There are many areas in the world, particularly where an expedition vessel could sail, that only have tracks of soundings, sometimes with the depth acquired by lead line. Wherever the mariner is working, acting in a prudent manner based on the source classification diagram on the chart is one of the duties required. Based on the choices made, the bridge team had committed the vessel to dire circumstances where their lack of planning and situational awareness had placed them.⁶⁵

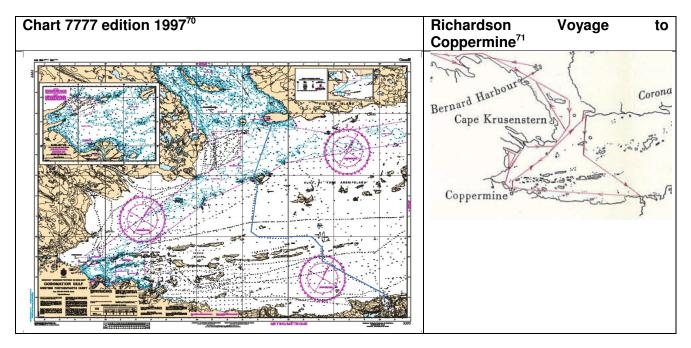
Figure 10CSS Richardson Track Sounding Route on 26 August 1965

The CSS **Richardson** departed Lady Franklin Point and sailed south southwest to the narrow passage through the Black Berry Islands, then sailed south toward the middle of the Lawford Island chain to the 68 degrees parallel of latitude, then sailed east to the passage between the Lawford and Home Islands and then through that passage, and then sailed south east to Port Epworth. The track of sounding route from Lady Franklin Point to Port Epworth is highlighted in the left Figure below, with the original sketch in the right Figure below.

The total distance from Lady Franklin Point to Port Epworth taken by CSS **Richardson** (indicated by the blue line overlaid on CHS Chart 7777 edition 1997 in the left figure above) was

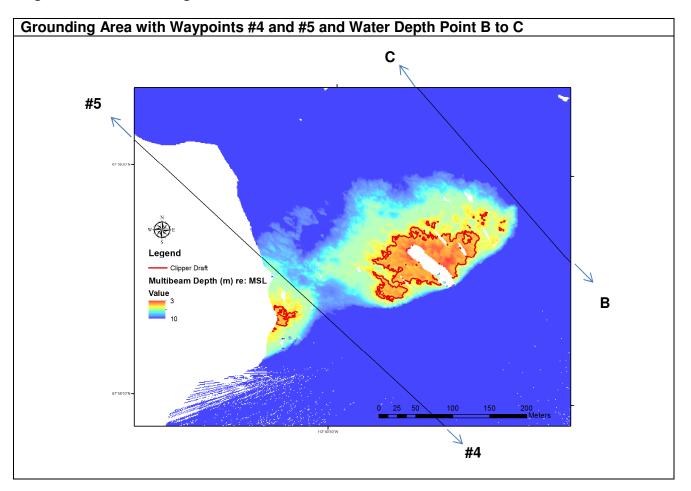
Figure 12 Grounding Area¹⁵⁶

Consequently, the **Clipper Adventurer** was neither following the Transas planned track nor was the vessel following the track of soundings. The course taken was in between, where the former and the latter offered safe passage. Unfortunately, the course taken by the **Clipper Adventurer** took the vessel over the shallowest part of the rock shoal.

Based on the multibeam echo sounder survey carried out by the **Amundsen Barge** the heading of the **Clipper Adventurer** when aground was 309.8 degrees True.¹⁵⁵ The Figure below shows the **Amundsen Barge** multibeam echo sounder data in the grounding area with the 4.8 metre contour. The line in the lower portion of the Figure is the Transas planned track between Waypoint #4 and #5. The line in the upper portion of the Figure is the line between water depth points B and C.
