# **A Tale of Two Bridges**

## **A Comparison of Tyrone and Runnyford Bridge Constructions**

Royce Toohey, Support Services Engineer, Eurobodalla Shire Council

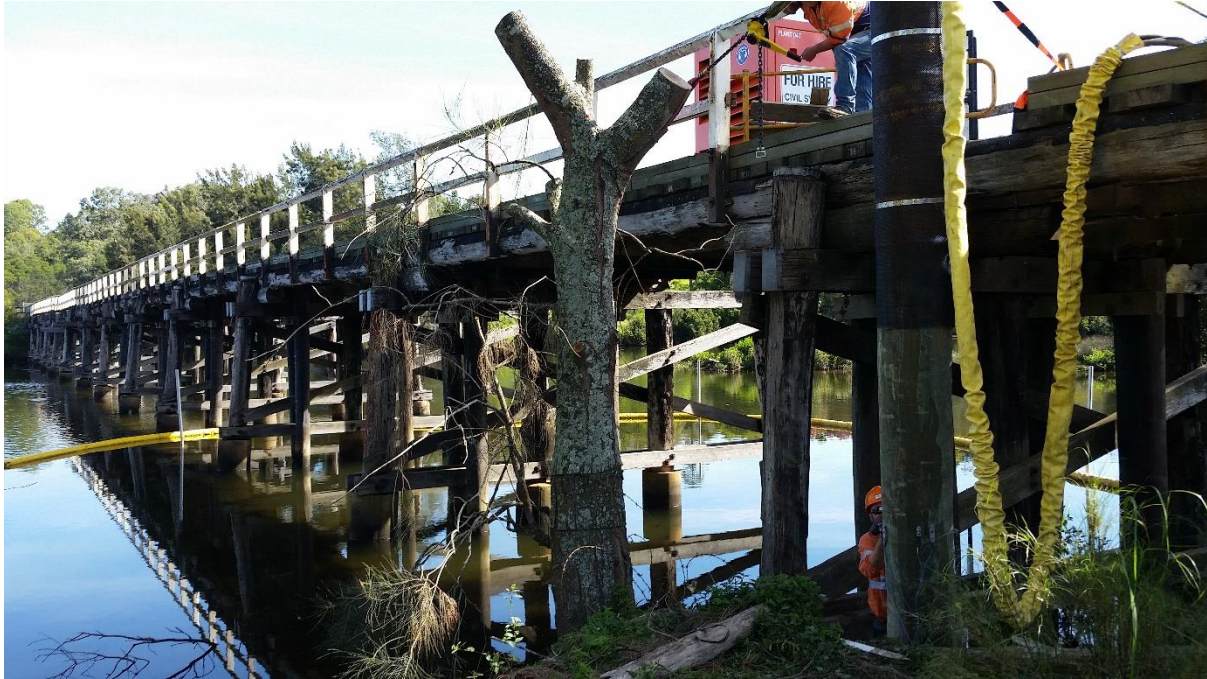
Figure 1- Runnyford Bridge

A high level, 130m long, timber bridge, it is located west of Batemans Bay, approx. 10km north-west of the Princes Hwy, where Runnyford Road crosses over the Buckenbowra River. It is composed of 13 x 10m long spans, each span constructed from timber girders and supported on piers constructed from timber piles. Some piers at the time of reconstruction were rotten through and supported by steel piles driven adjacent.

The bridge was constructed in about 1953 to a (then) DMR design with subsequent alterations in the intervening years.

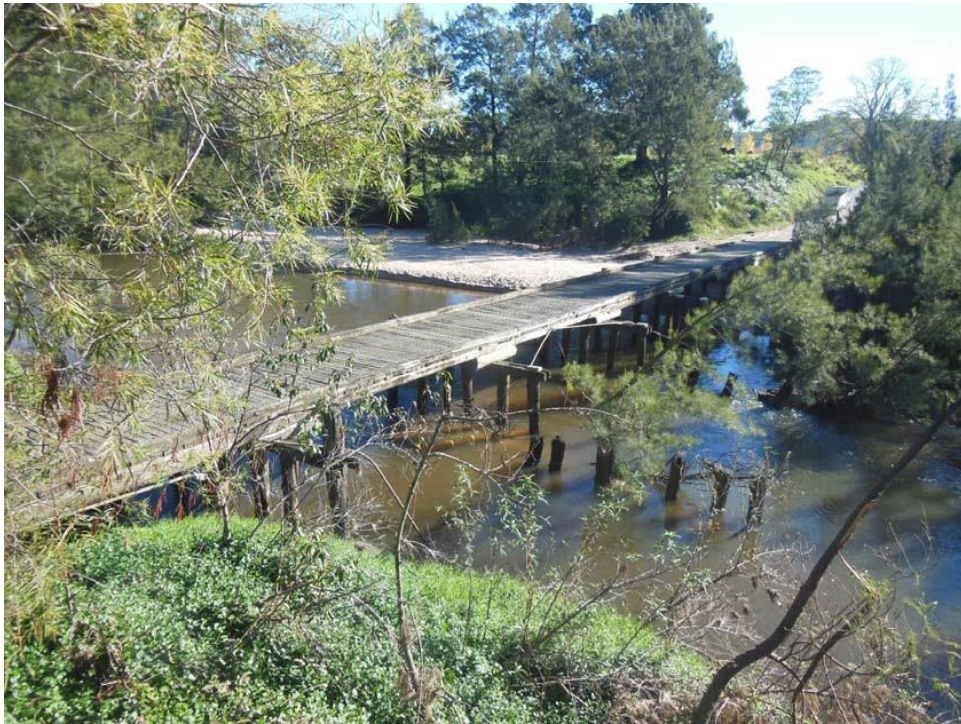
**Figure 4- Existing Tyrone Bridge**

Tyrone Bridge was a low-level timber bridge over the Tuross River at Eurobodalla, approx. 9km south-west of Bodalla.

The bridge posed a number of issues for both the local community and Council, including being regularly overtopped as the deck was at a level equivalent to the 200% AEP flood event for the river. These operational issues had significant impacts on regional industries, including steep drop-down and rise from surrounding roads to the bridge deck resulting in significant strain on heavy vehicles using the bridge, routing closure due to flooding, and a high risk factor due to difficulty in assessing the impact of a flood event on the bridge before allowing re-opening.

The structural assessment indicated a 5t limit was required for T44 vehicles and 10 tonne for SM1600 vehicles due to its extremely poor state.

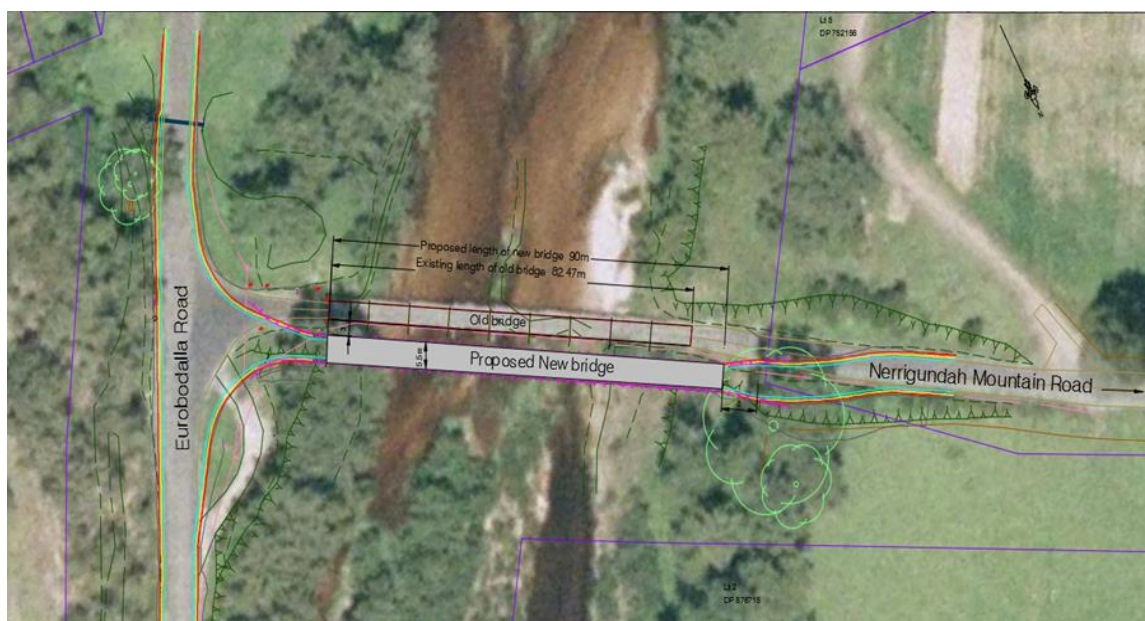
**Figure 6- Proposal for Replacement of Tyrone Bridge**

Concept planning was begun on a replacement. To limit the impact on transport movements and local traffic (alternative was a 17km detour from Cadgee or a 23km round trip for those close to the bridge), it was determined that the existing bridge needed to be kept operational during any construction so a new alignment chosen downstream (actually the site of the first bridge over river) to allow construction to occur without impacting traffic.

The successful tenderers proposed an alternate design that allowed a 90m concrete bridge rather than the concept 80m bridge. This was accepted.
