Improving System Protection Reliability and Security

Steve Turner
Beckwith Electric
STurner@BeckwithElectric.com

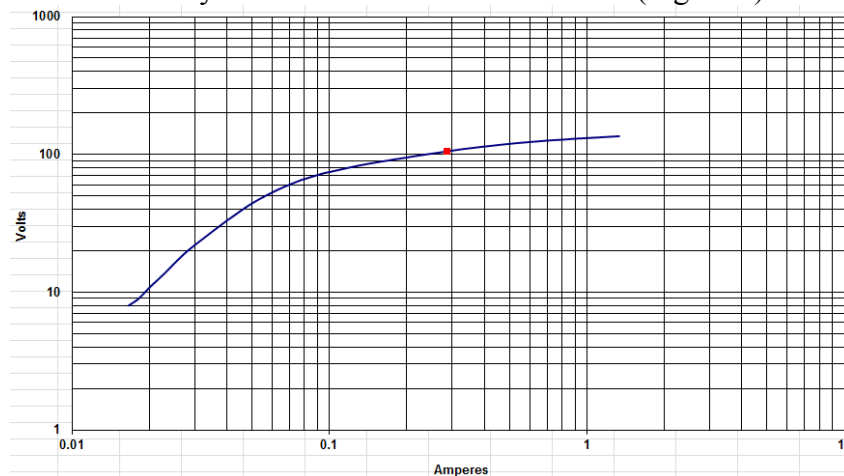
Figure 3. C Phase Neutral Side CT Excitation Characteristic

Review of the relay settings revealed the relay that did not trip had a higher pickup setting by a factor <u>greater than four times.</u> The CTs have a knee point of 100 volts or less which is low and there was the presence of heavy dc offset in the C-Phase current (Figure 3).

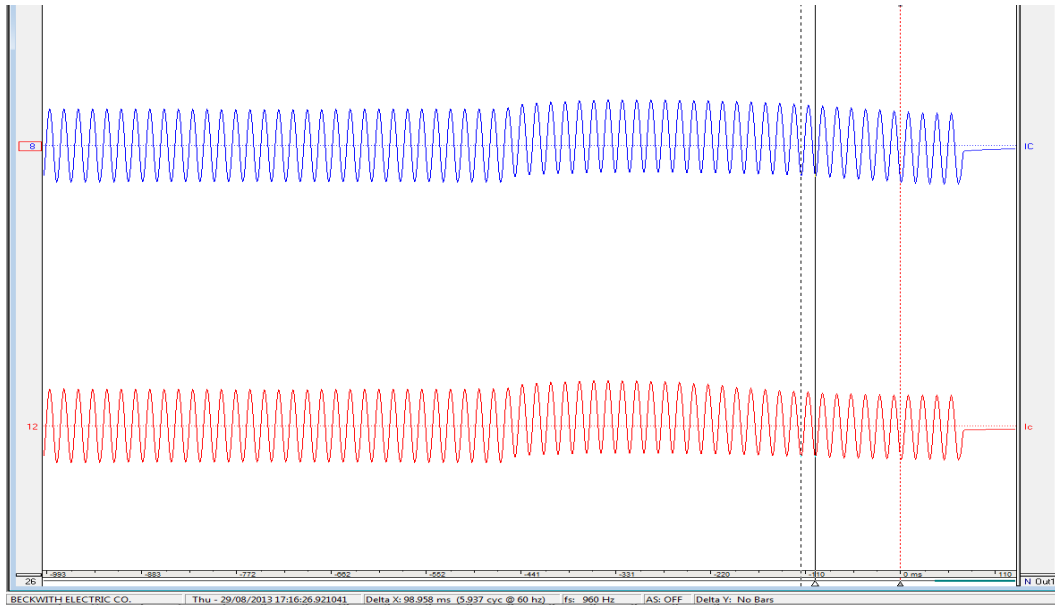
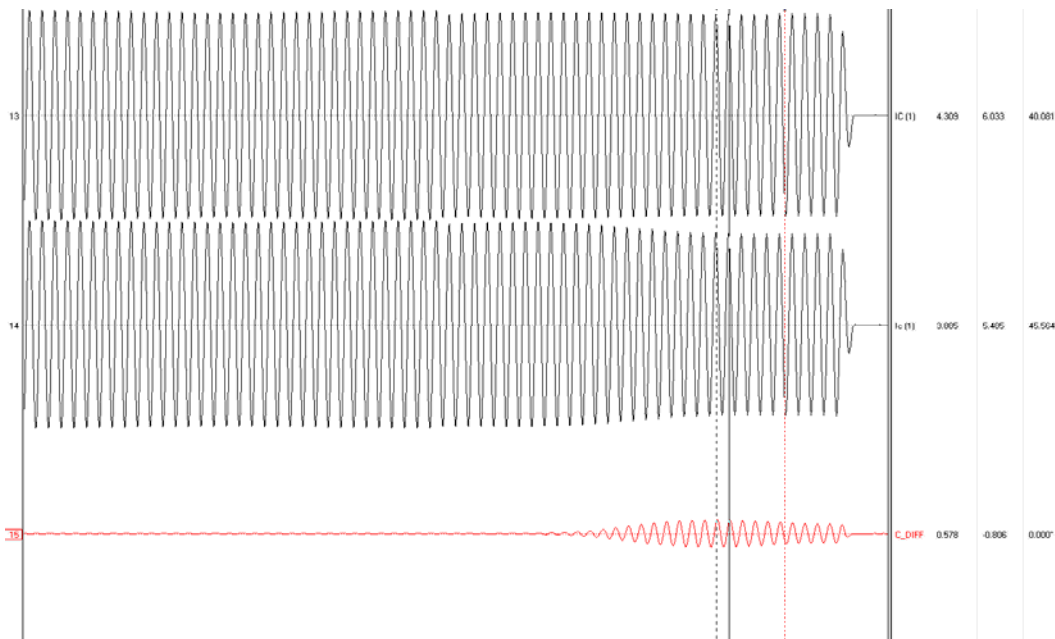
**Figure 4A. Generator C-Phase Current**

Figures 4A and 4B show the high levels of dc offset present in C-Phase current during the event. DC offset current is the number one cause of CT saturation.

Detailed calculations are necessary for generator differential protection to determine if CTs can saturate; do not simply copy settings from the relay instruction book without actual verification.

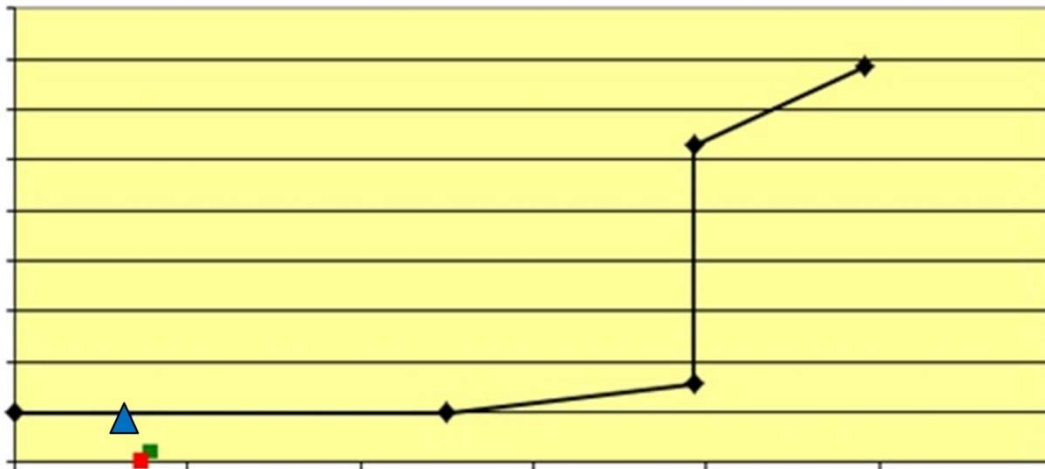
Figure 6. 87 Phase Differential Operating Characteristic

The blue triangle in Figure 6 corresponds to the C-Phase operating point which was just on the boundary of operation. The misoperation occurred when the current was coming out of saturation.

Best Practice: If the DC offset from transformer inrush (e.g., black start) or fault condition can cause CT saturation, then the following are appropriate for generator phase differential protection settings:

- Minimum pickup up to 0.5 amps secondary
- Slope of 20 percent
- Time delay up to 5 – 8 cycles

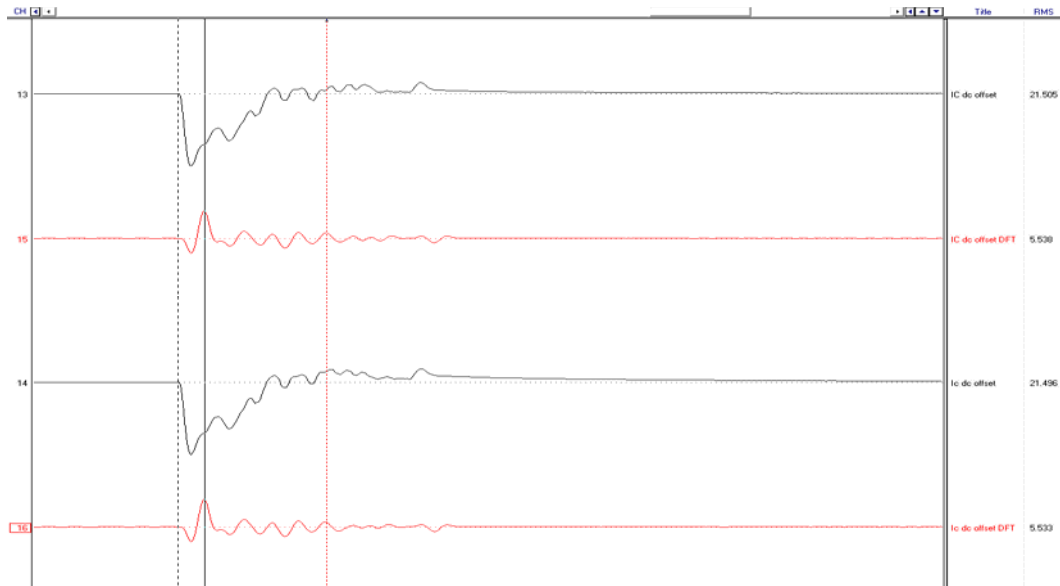
Figure 7. DC Offset Current

The DC offset present in fault current exponentially decays as shown in Figure 7. The digital Fourier transform algorithm cannot fully reject it.

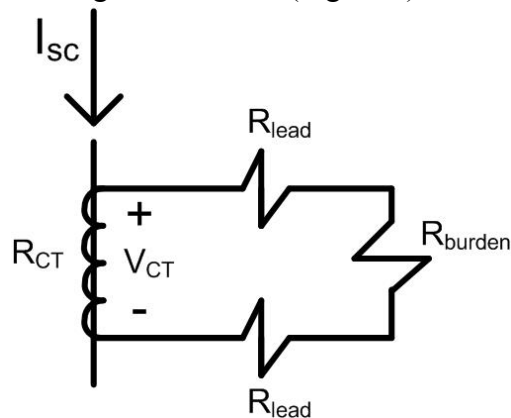
Figure 8. CT Saturation Calculation

Higher C class CTs can help to mitigate saturation (Figure 8).

$$V_{CT}{}^{MAX} = 2 \bullet (R_{CT} + 2 \bullet R_{lead} + R_{burden})$$

The factor of 2 accounts for a fully offset current waveform which is worse case.

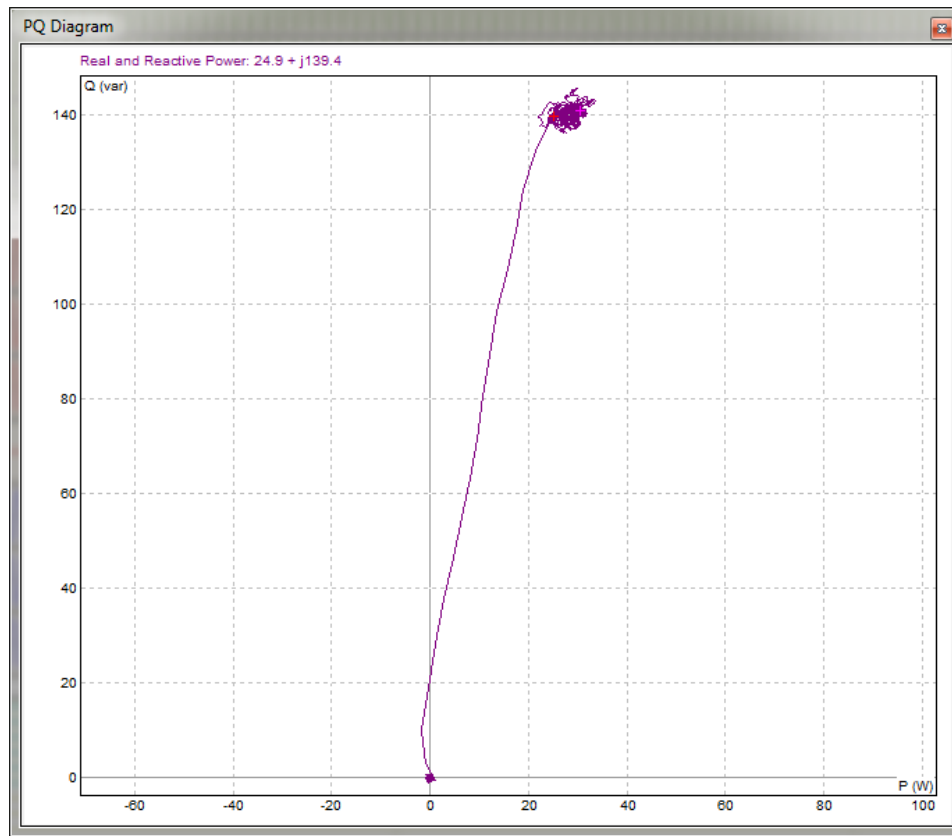
Figure 9. Machine Real and Reactive Power at time of 27TN Trip

<u>27TN Third Harmonic Neutral Undervoltage</u>
A utility experienced several misoperations when system voltage was low. However, the trip shown in Figure 9 occurred when the machine was under excited and drawing vars from system.

The solution for this particular machine is to <u>block on low forward power</u> as this is the prevailing system condition when the nuisance trip occurs. The main drawback to this solution is there is no protection for stator ground faults close to neutral during this operating condition.

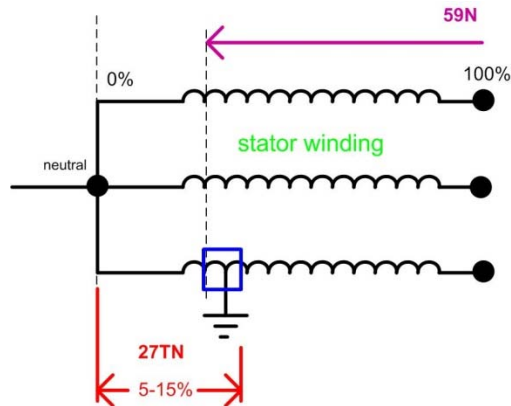
Figure 10. 27TN and 59N Zones of Stator Ground Fault Protection

Conventional protection (59N) cannot detect grounds in last 5 to 10 percent of stator winding. 27TN is not always reliable and may have to be blocked during specific operating conditions. If failure occurs in lower voltage portion of winding near neutral, a generator trip will not typically occur until some other relay protection detects there is a problem, (e.g., arcing becomes so widespread that other portions of winding become involved). 27TN sees stator ground faults very close to the machine neutral as shown in Figure 10.

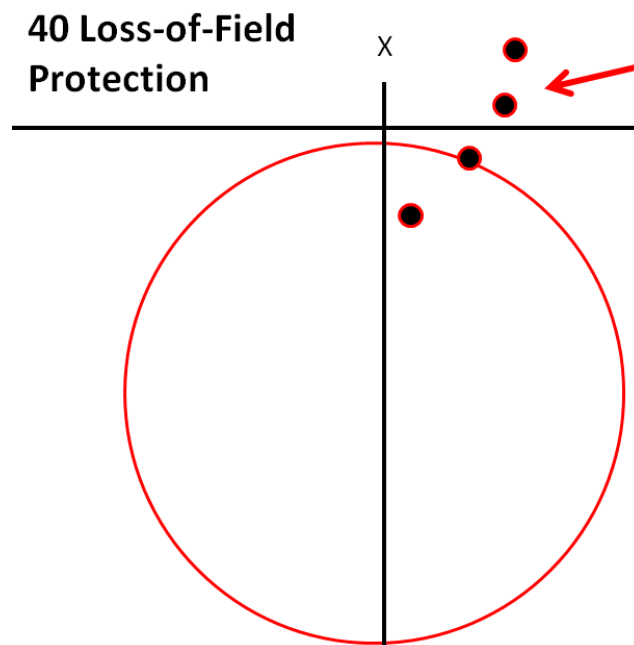
Figure 16. 40 Loss-of-Field Protection

Two customers experienced generator protection misoperations due to incorrect phase rotation settings. The first misoperation was 40 loss-of-field protection (Figure 16).

Sequence of events:
- 40 operates on Z_1 (positive-sequence impedance)
- 40 measures incorrect impedance due to <u>wrong phase rotation setting</u>
- 40 trips each time customer attempts to synch the generator to the grid

Best Practice: Modern numerical relays have built-in tools provided to determine the <u>actual</u> phase rotation. Phase rotation can quickly be checked using numerical relay metering.

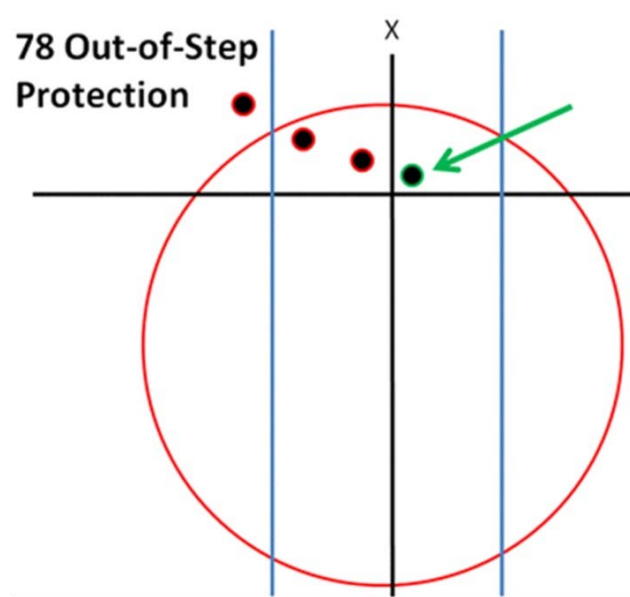
Figure 17. 78 Out-of-Step Protection

The second misoperation was 78 out-of-step protection (Figure 17).

Sequence of events:
- 78 operates on Z_1 (positive-sequence impedance)
- 78 measures incorrect impedance due to <u>wrong phase rotation setting</u>
- 78 tripped during external event

How did either incorrect relay setting make it past commissioning? Both elements (40 and 78) were effectively operating on Z_2 (negative-sequence impedance) due to the incorrect phase rotation settings.
