Clipper Adventurer Grounding: Background and Geomatics Issues Bruce Calderbank, FRICS, CLS, CH, P. Eng. Chartered Hydrographic Surveyor, Certified Hydrographer Level 1 Hydrographic Survey Consultants Intl. Ltd., Calgary, Alberta, Canada

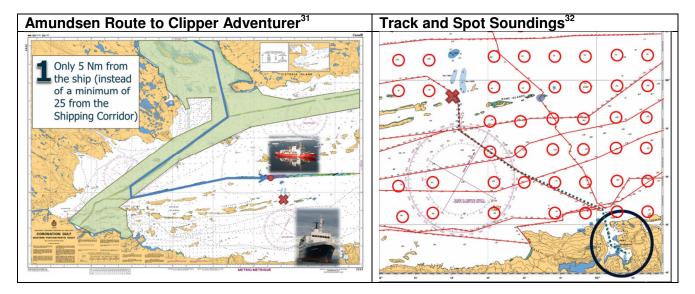
Figure 4 Route to Clipper Adventurer and Soundings

This brought the CCGS **Amundsen** to within 5 nautical miles of the grounded **Clipper Adventurer** instead of a minimum of 25 nautical miles from the shipping corridor as shown in the left Figure below. However, this area was only covered with spot sounding observed by helicopter every 6 kilometres and track of soundings of various vintages as shown in the right Figure below. The spot soundings observed by helicopter had been observed years before in winter when there was thick ice coverage over Coronation Gulf. The "X" in both images marks the location of the **Clipper Adventurer** grounding as established by the **Amundsen Barge**.

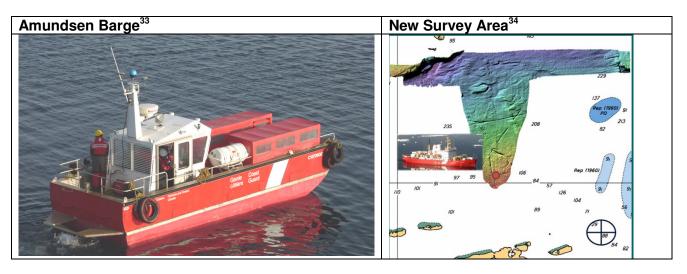
Figure 5 Amundsen Barge and New Survey Area

To allow the CCGS **Amundsen** to sail south towards the grounded **Clipper Adventurer**, a route had to be surveyed to the track of soundings to the south as there was no bathymetric coverage in that area. The **Amundsen Barge** was deployed to survey this area as shown in the right Figure below. The crosshairs symbol marks the location of the **Clipper Adventurer** grounding as established by the **Amundsen Barge** in the left Figure below.

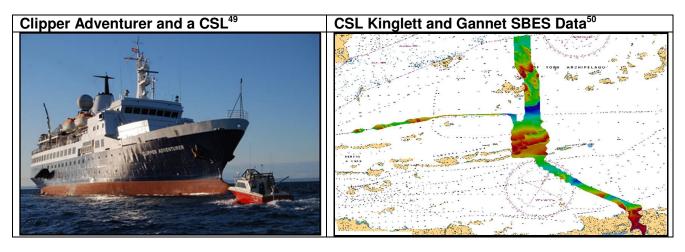
Figure 6 CSL at Work and Survey Results

These surveys provided a shipping corridor from the Cache Point Channel in the Dolphin and Union Strait directly to Port Epworth. In the right Figure below, the narrow band of bathymetry running from the grounding area towards Kugluktuk, was acquired by CCGS **Amundsen** in 2005, 2006 and 2010.
